Manhole Inspection Summary

Manhole # S43CC_035MH

Location Address: **1715 E EAGER ST**

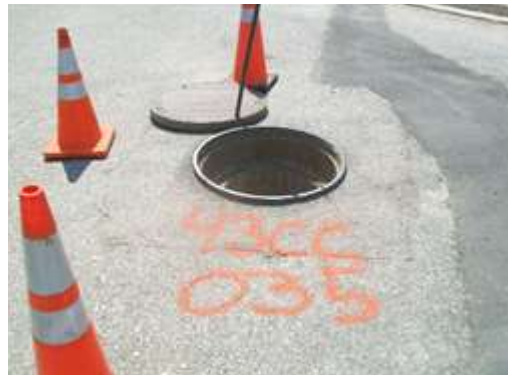
MISC.

PAVEMENT MARKED

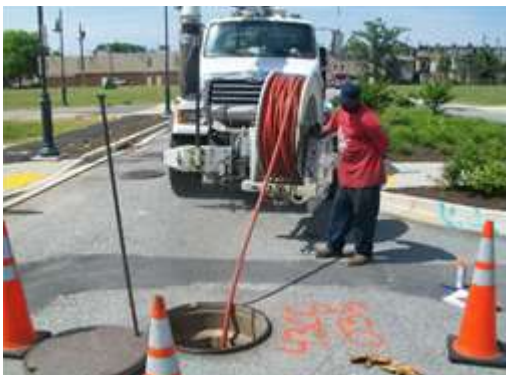
CLEANING

Comments **DEBRIS REMOVED BY VAC-CON, FLUSHED PIPES FROM MANHOLE; FRAME IS NOT ABOVE GRADE - FINISHED PAVING GRADE NOT IN PLACE**
